SANGFOR

NGAF

Network port rate is abnormal troubleshooting

Version 8.0.6

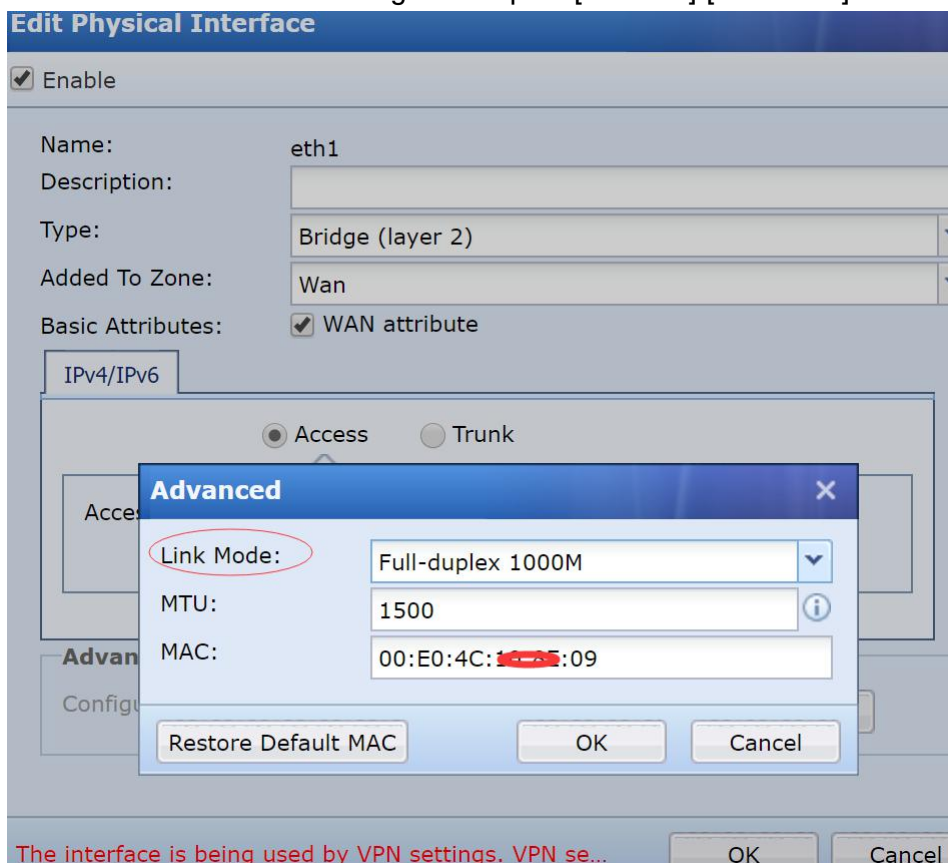
1. Check whether the rate of the interface port of the directly connected abnormal network port supports Gigabit.
2. Try to manually specify the rate of the network ports on both ends to check whether the network is normal. Configuration path:[Network]-[Interfaces].

3. Check the system log for any abnormalities, Log view path:[System]-[Troubleshooting]-[Logs].
4. Try replacing the network cable to test if the network is normal.
5. Replace the switch port test and check whether the port is abnormal.
