# **Sangor VPN**

## **Troubleshooting guide for Sangor VPN build up failure**

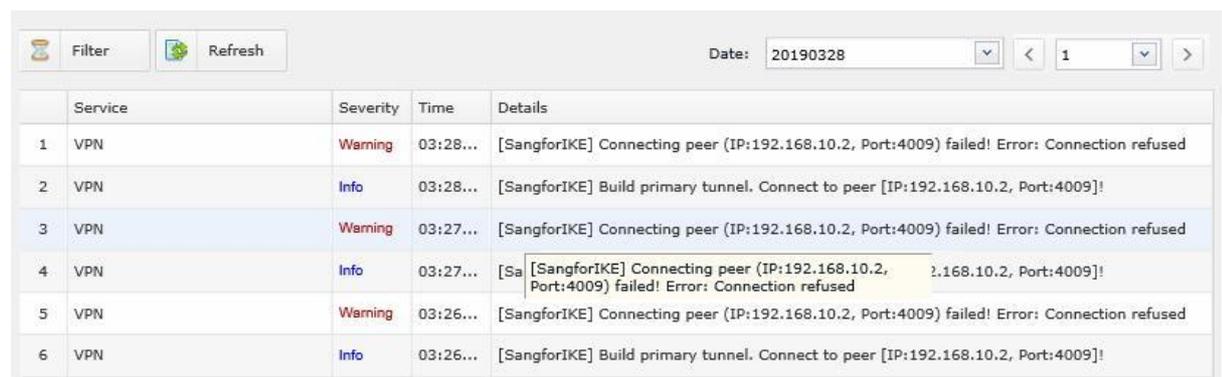
##### 1. System Logs:

Service	Severity	Time	Details
1	VPN	Warning	03:28...	[SangforIKE] Connecting peer (IP:192.168.10.2, Port:4009) failed! Error: Connection refused
2	VPN	Info	03:28...	[SangforIKE] Build primary tunnel. Connect to peer [IP:192.168.10.2, Port:4009]!
3	VPN	Warning	03:27...	[SangforIKE] Connecting peer (IP:192.168.10.2, Port:4009) failed! Error: Connection refused
4	VPN	Info	03:27...	[SangforIKE] Connecting peer (IP:192.168.10.2, Port:4009) failed! Error: Connection refused
5	VPN	Warning	03:26...	[SangforIKE] Connecting peer (IP:192.168.10.2, Port:4009) failed! Error: Connection refused
6	VPN	Info	03:26...	[SangforIKE] Build primary tunnel. Connect to peer [IP:192.168.10.2, Port:4009]!

- i. VPN listening port – 4009 is blocked or incorrect.
- ii. VPN service did not enable/start
- iii. Incorrect VPN user configuration
- iv. Incorrect Client side configuration

- i. Ensure the listening port 4009 is allowed in both side. If the listening port is not 4009, change at the peer side configuration as well.
- ii. Ensure the VPN service at both side is enabled/started.
